Site No. 2

GANO STREET RECREATION AREA

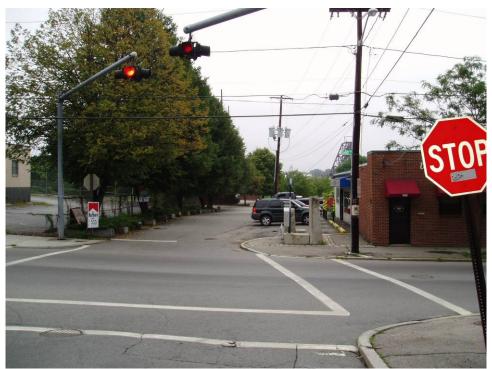
Photo 1. Entrance to Gano Street Recreation Area looking east.

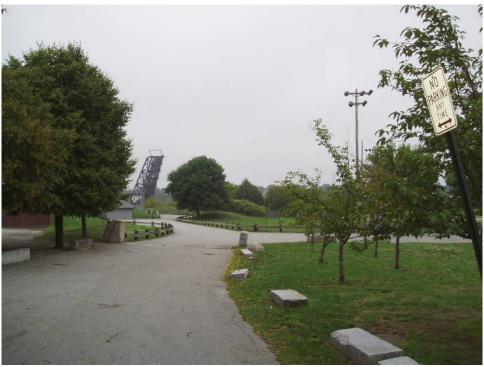
Athletic fields within the site are used heavily by local sport leagues both on weekends and weeknights, and both soccer and softball fields are lighted. The limited amount of parking within the site is insufficient for demand during these periods of peak use; during such times excess vehicles often park illegally within the site or along nearby local streets.

Photo 2. Internal access roads within recreation area. The granite slabs have been placed to prohibit parking along the shoulder.

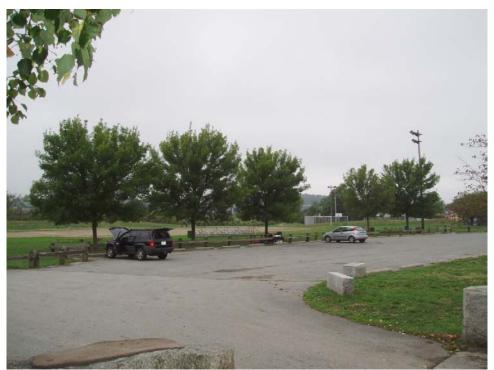
Photo 3. Parking lot and soccer field looking southeast.

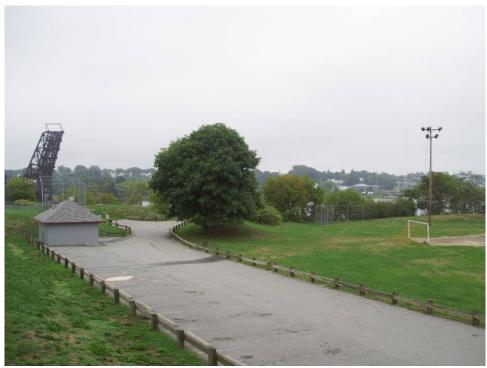
Environmental Constraints and Permitting. A vegetative buffer runs along the length of the parcel between the Seekonk River and athletic fields (see Photos 4, 6, 8). The inland edge of coastal feature is the top of bank, from which invasive species extend to the edge of water. Eel grass was not observed. This area of the Seekonk River classified by the CRMC as Type 4 (Multipurpose) waters and also regulated under the Providence River Special Area Management Plan.

Photo 4. Recreation Area and Seekonk River looking east from top of softball field bleachers.

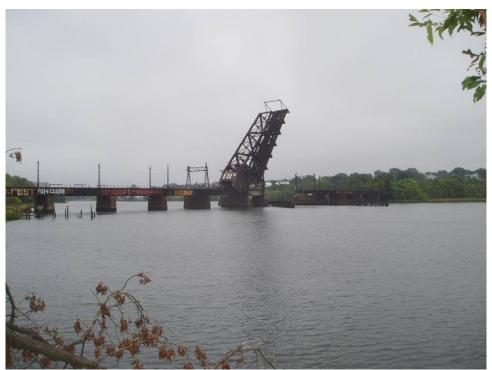
The Gano Street Recreation Area currently has little to offer in terms of public fishing accessibility. As previously noted, there is a lack of viable fishing spots within the site due to the steep-banked shoreline and vegetative buffer along the Seekonk River. Of the 387 responses to the Online Recreational Fishing Survey, only 1 participant reported fishing from the Gano Street facility. The site's on-site parking capacity (approximately 65 vehicles) is currently inadequate during peak use of the area, and there is limited additional area within the park to further develop additional parking or facilities. The exception is a small clearing at the end of the access road beyond the little league field (see Photo 6) which may be suitable for small-scale development. The abandoned railroad bridge is accessible via a path from this clearing, and though once gated off and closed to the public for safety concerns, this structure was readily accessible upon site visit (sees Photo 5). It should be noted that this bridge is by no means a viable fishing structure due to the lack of railing, deteriorated condition of deck planks, etc.

Photo 5. Abandoned railroad drawbridge across Seekonk River.

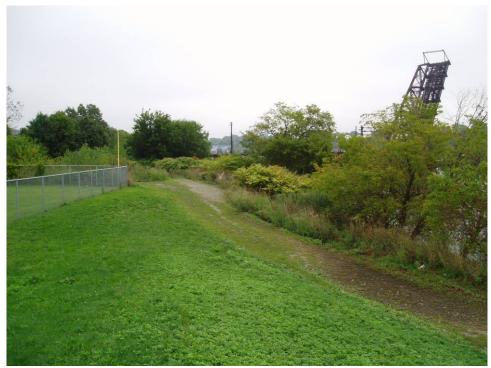
Photo 6. Dirt path along top of bank leading to abandoned railroad bridge.

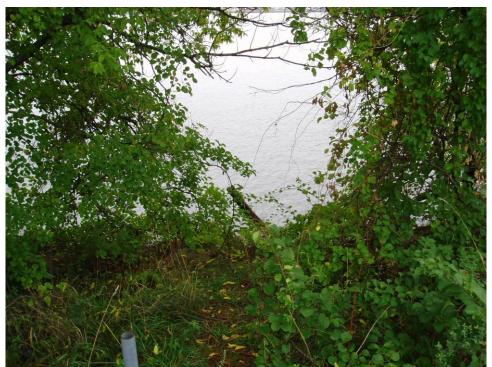
The shoreline feature at this location is generally not conducive to fishing access, as the ground elevation drops steeply (approximately 10-20 feet) from the top of bank to the water (see Photos 7, 8). The moderately dense vegetation along the riverbank also presents difficulties with both access and line casting.

Photo 7. Typical shoreline access within recreation area. The steep banks and dense brush along the river are not conducive to fishing within the site.

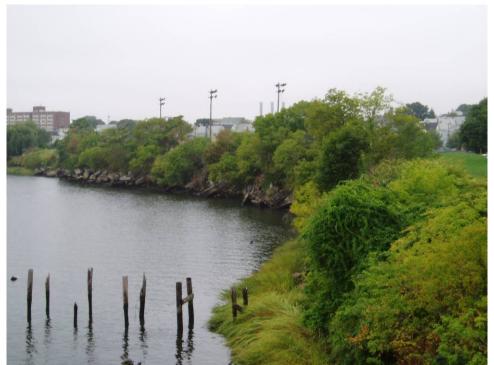
Photo 8. Recreation area shoreline looking southwest from near abandoned railroad bridge.
